THE REHABILITATION OF A CONCRETE PAVEMENT USING IN-PLACE RUBBLIZATION AND COLD RECYCLING TECHNOLOGIES

Tony DECOO, C.E.T.
County of Oxford
Woodstock, Ontario, Canada

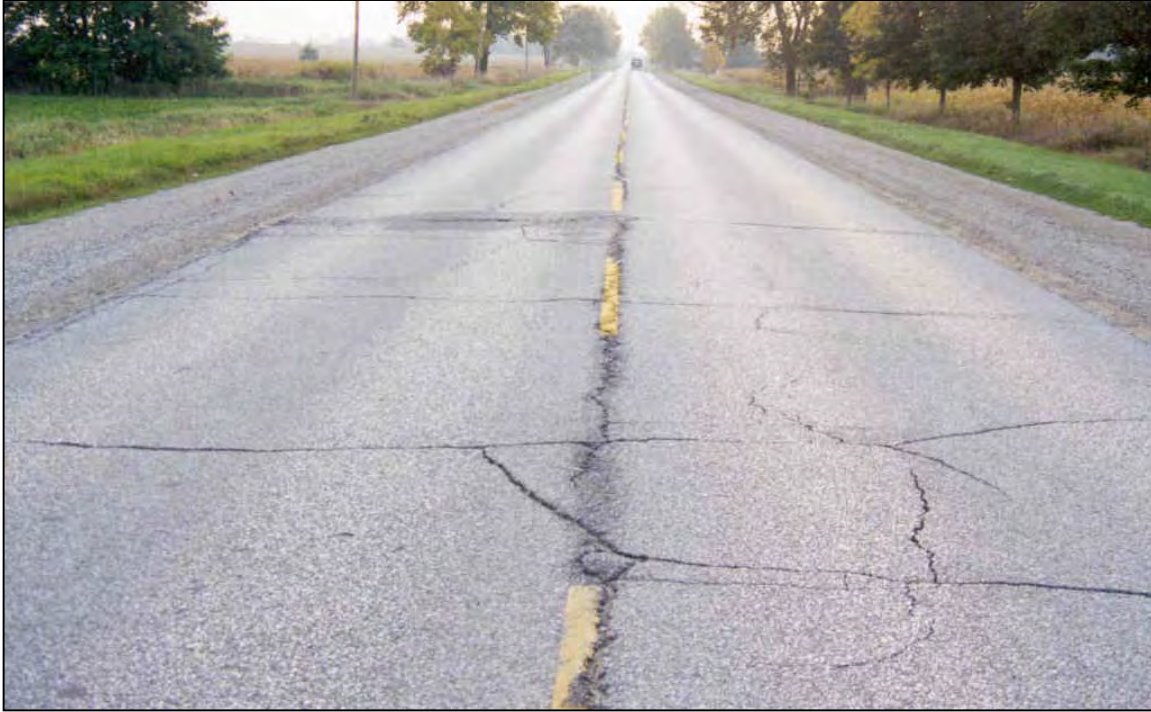
The Pavement Condition Index (PCI) in 1995, just before the highway was transferred, was about 50. The condition of the existing pavement was considered to be poor. The surface exhibited severe cracking. Blown up joints were relatively frequent. Milling was often necessary to restore the longitudinal profile of the road at the joint. Load transfer from one slab to another was very poor. As a result rocking of the slab was frequent and in many cases the movement of the slabs could be observed with the naked eye. Consequently the riding condition of the road was considered very poor. Photograph 1 shows the typical condition of the County Road 2 pavement prior to rehabilitation.

Photograph 1: Typical condition of County Road 2 prior to rehabilitation

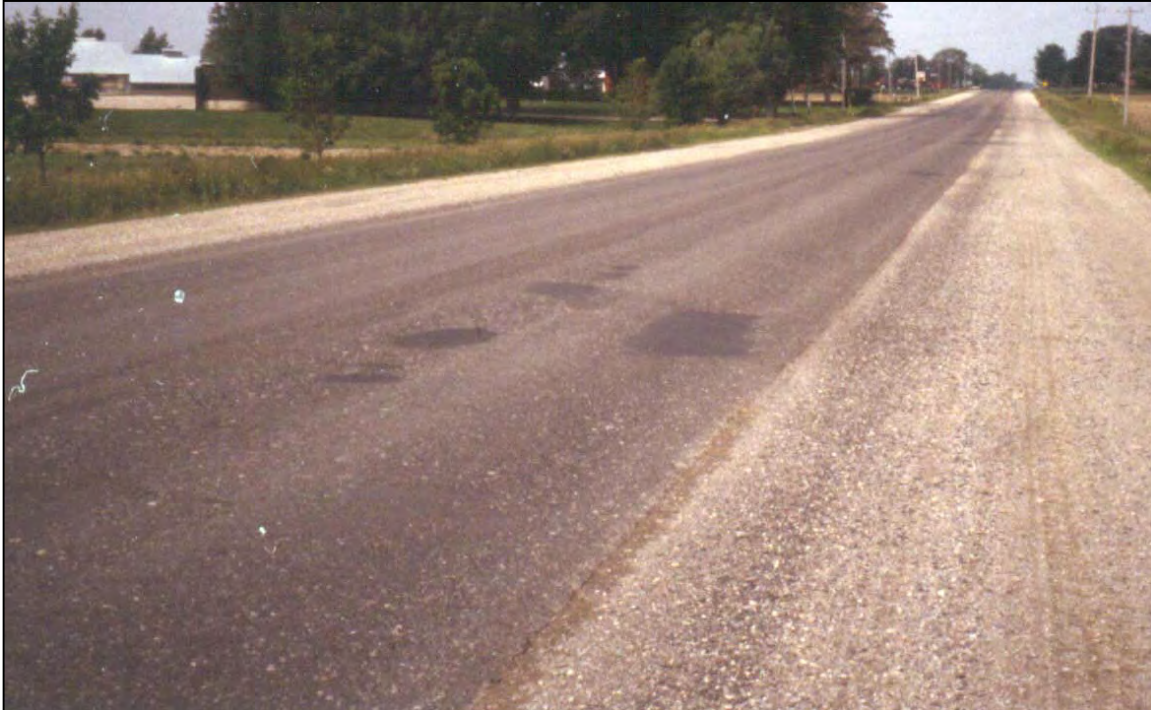
Segregation of the cold recycled material created significant difficulties. The cold recycled material was placed using a standard paver. Standard pavers are sometimes the source of systematic segregation. They are designed to place HMA that are finer than the cold recycled material specified for County Road 2. The cold recycled mixture specified for County Road 2 was coarse and its workability was difficult. Segregation turned out to be very difficult to control and it became a major concern. Segregation was frequent and the mixture was particularly prone to raveling in segregated areas. In some cases, surface raveling became so severe that the recycled mat potholed as well (Photograph 2).

Photograph 2: Raveling of recycled mat leading to potholing

The mix-paver also provided the solution to the segregation problem. The pugmill system of the mix-paver and the outboard driven auger system that distributes the recycled material in front of the paver screed in essence eliminated the occurrence of segregation. No repairs related to segregation were necessary in the section of County Road 2 where the recycled mix was placed using the mix-paver.

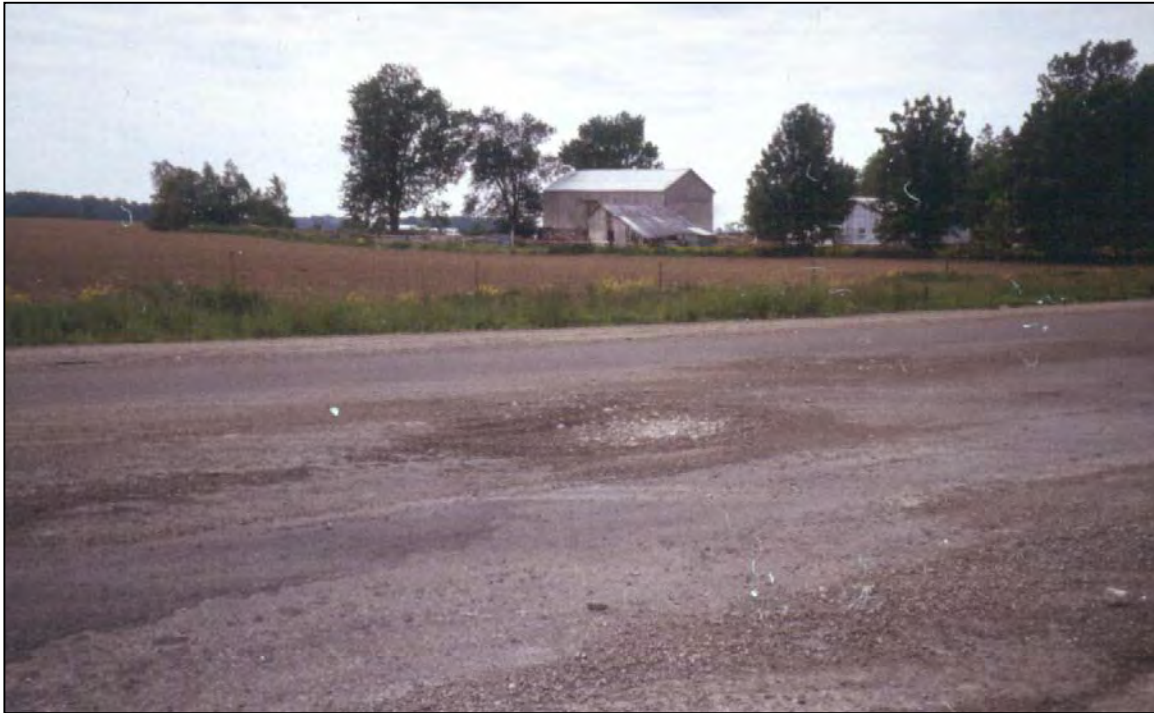
After rubblization, proof rolling was performed to seat the rubblized concrete and also to identify potential soft zones or unstable areas. Proof rolling was not totally effective to identify these areas. In many cases the unstable areas would develop with the dynamic action of the traffic riding on the freshly placed cold recycled mat. As a result, sporadic areas of the cold recycled mat would breakup. In some cases the subgrade became sufficiently unstable to cause the protrusion of rubblized concrete chunks through the recycled mat. Photograph 3 shows a localized breakup area of the recycled mat with the appearance of concrete chunks.

The frequent development of unstable areas may have been amplified by wet weather conditions that prevailed in May 2000. The spring of 2000 was exceptionally wet. The complete removal of the HMA cover exposing the concrete may have allowed the rain to penetrate the sub-grade at the slab joints reducing the bearing capacity of the subgrade. In addition, it was found during construction that some of the drains installed in 1978 were plugged, resulting again in a lack of drainage of the subgrade.

Photograph 3: Localized rapid breakup of recycled mat

At first the unstable areas were repaired using the remove-and-replace method. The remove-and-replace method was still not considered adequate because it created discontinuities in the pavement structure. Furthermore, the dynamic action of the traffic was always creating more unstable areas that would eventually breakup. Not only was a measure needed to be taken to correct the areas that were broken up, but it was also necessary to find a solution to stop the appearance of new unstable areas due to the dynamic action of the traffic.

On a Friday afternoon, because of the weekend and the lack of time to correct a broken up area using the remove-and-replace method, it was decided to place a 50 mm temporary intermediate layer of HMA on top of the broken up area. The intent was to hold the surface for the weekend and on Monday the area would be repaired using the remove-and-replace method. On the

following Monday, not only the temporary intermediate HMA layer held the surface, but it appeared to have helped the recycled cold mix to build up strength. The area was no longer moving or showing any signs of deterioration. The remaining unstable areas were corrected using this method.

To stop the appearance of new unstable areas due to the dynamic action of the traffic, it was decided to use this 50 mm HMA intermediate layer method over the entire length of the 8.5 km section. In order to make sure that the appearance of new unstable areas was definitely under control, the placement of the final HMA surfacing was delayed two months. The intermediate layer held up well and no other repairs were required in the two-month period before the placement of the surfacing layer.

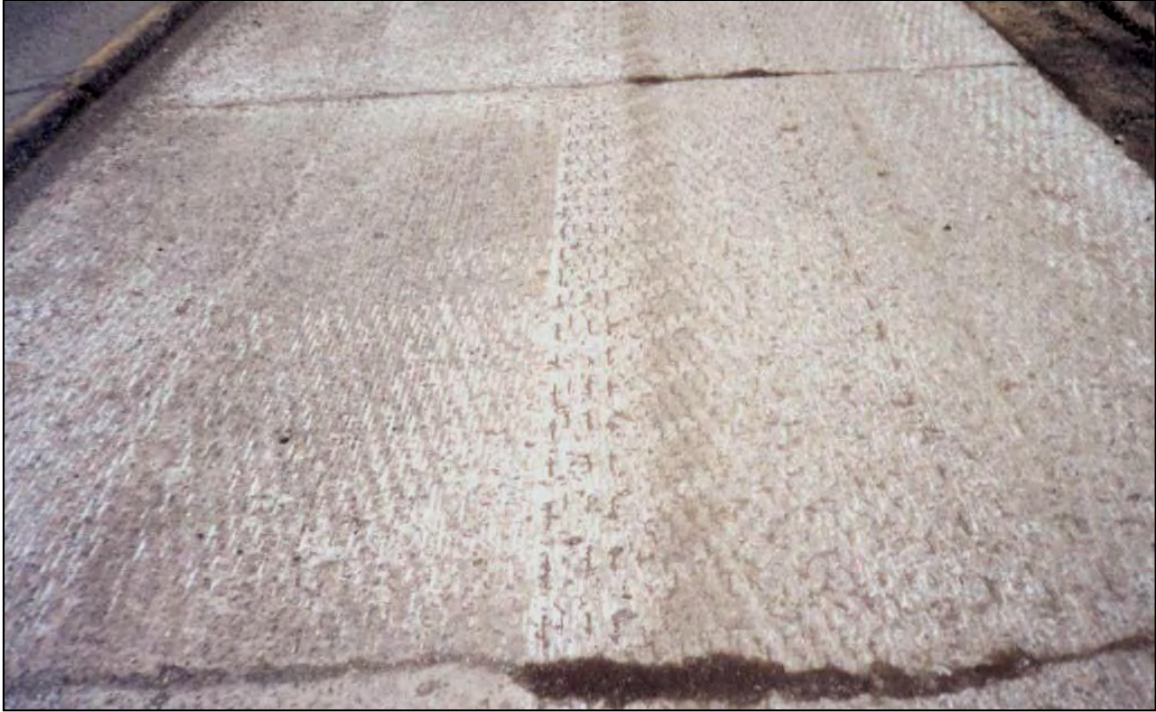
The milling operation was carried out using a standard 2-m milling machine. The full depth of the existing HMA was removed as well as the underlying surface of the concrete leaving a bear concrete surface (Photograph 4) which is required for the rubblizing operation. Three resonance breaker machines working in echelon were used to rubblize the concrete (Photograph 5 & 6). A 12-tonnes single drum roller was used to proof roll the rubblized concrete.

Photograph 4: Milled surface of concrete slab before rubblization

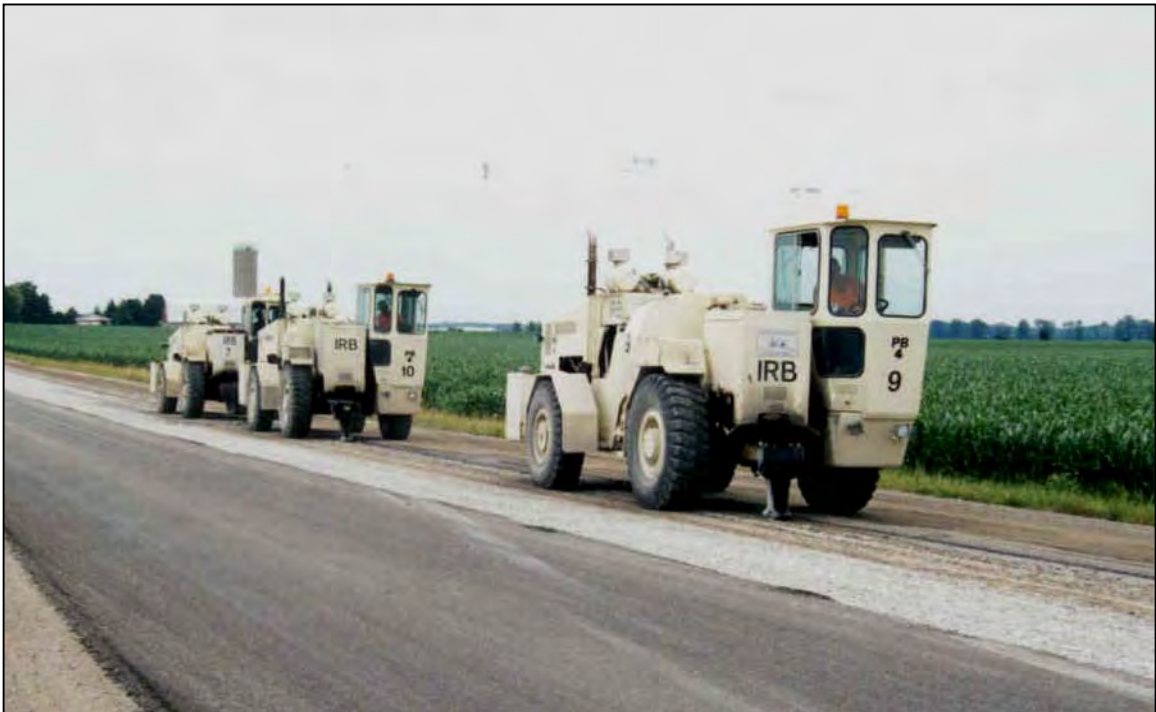
Photograph 5: Resonance breaker working in echelon

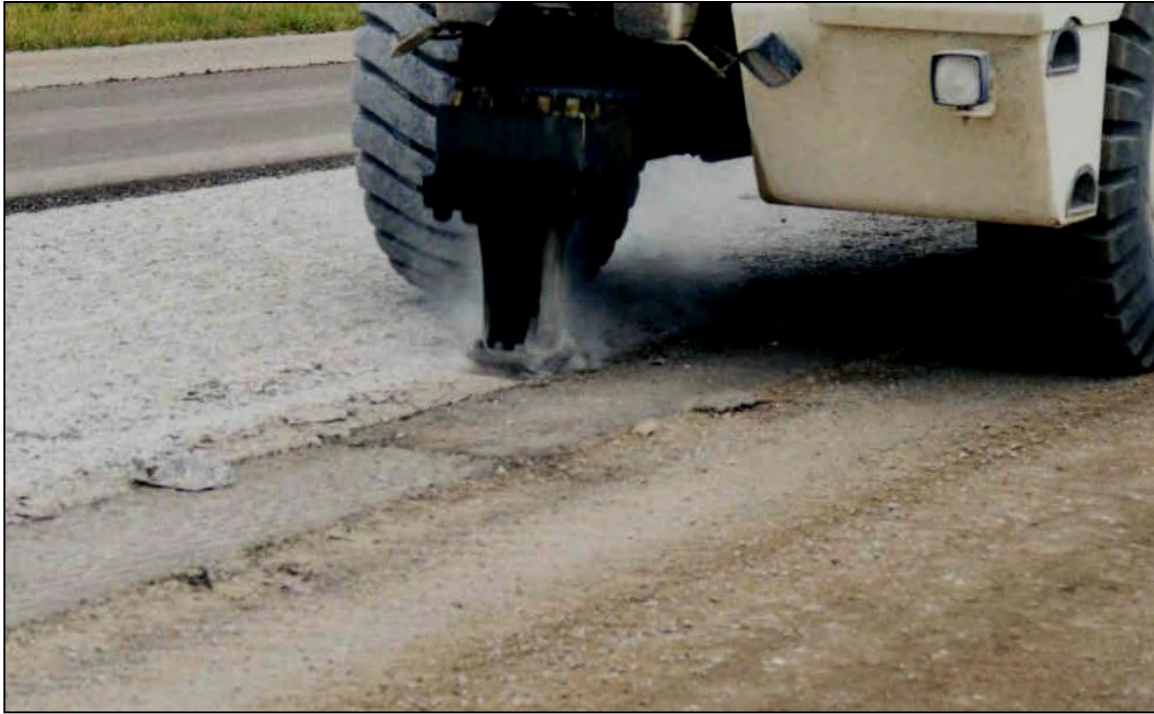
Photograph 6: Resonance breaker shoe

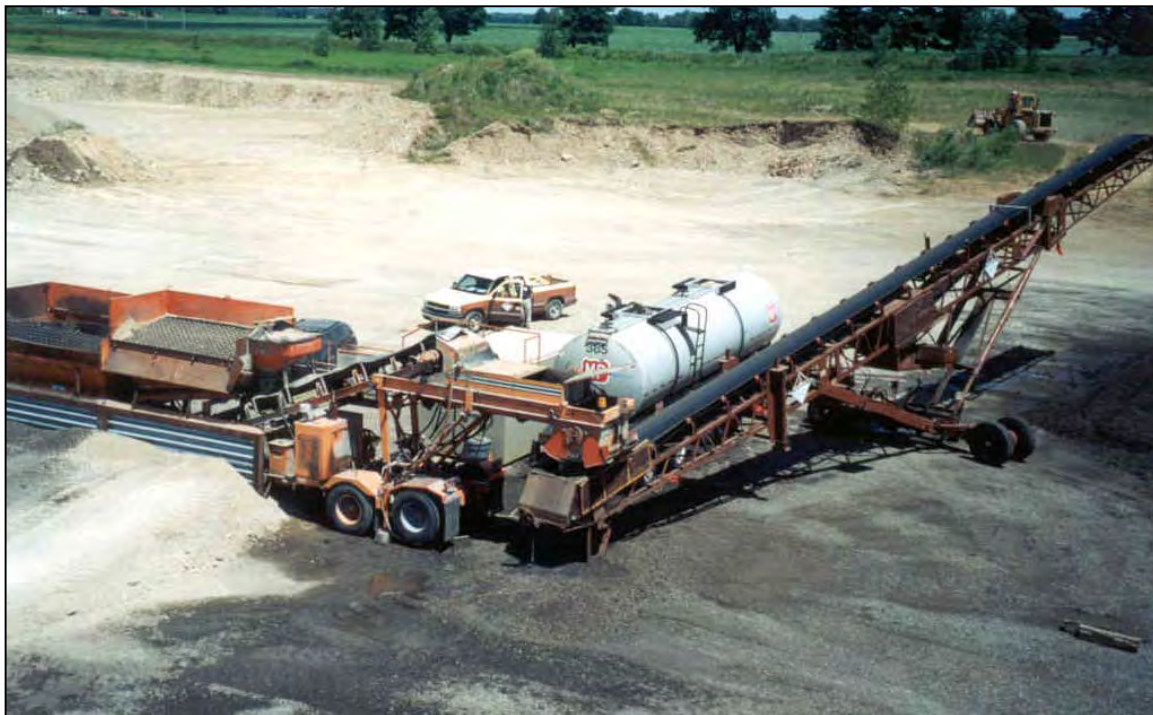
The stockpiled cold recycled mixture was produced using a two-bin cold mix plant (Photograph 7). A stockpile of cold recycled mixture was produced every day. The stockpiled mixture was placed onto the rubblized concrete approximately 24 hrs after being produced (Photograph 8). The rubblizing operation would start only when sufficient recycled cold mix was already produced to cover the daily area rubblized. The placement of the cold recycled mix was carried out using conventional paving equipment.

Photograph 7: Two-bin cold mix plant

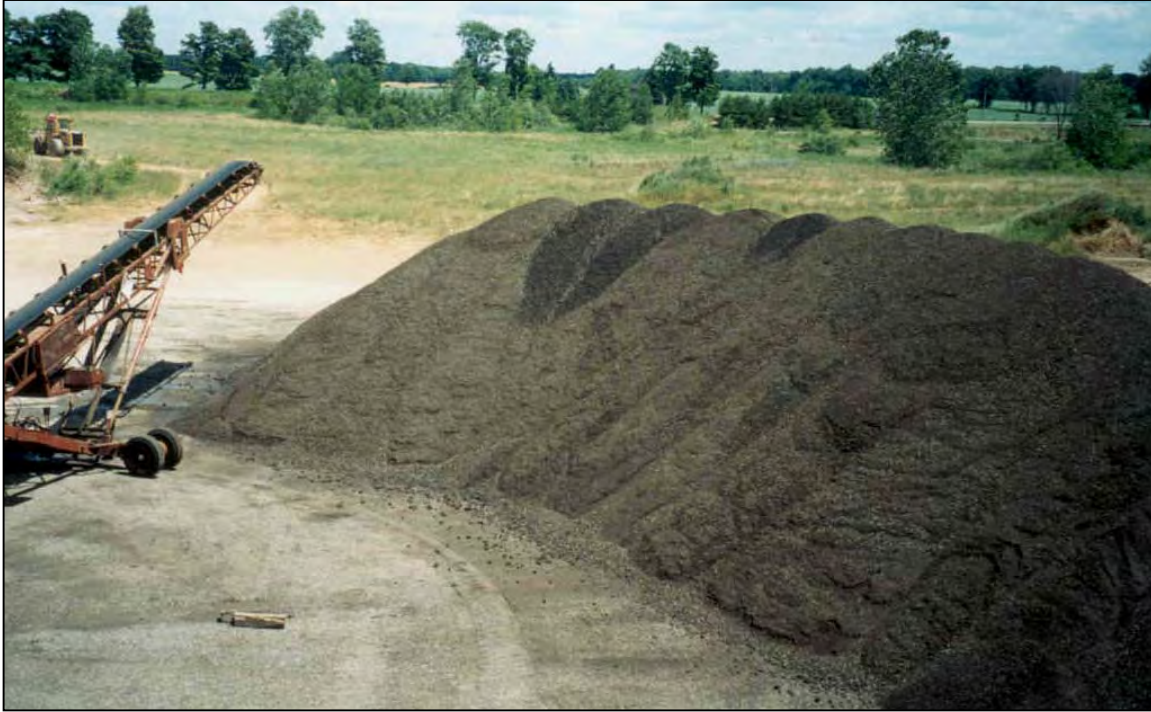
Photograph 8: Stockpiled recycled cold mixture

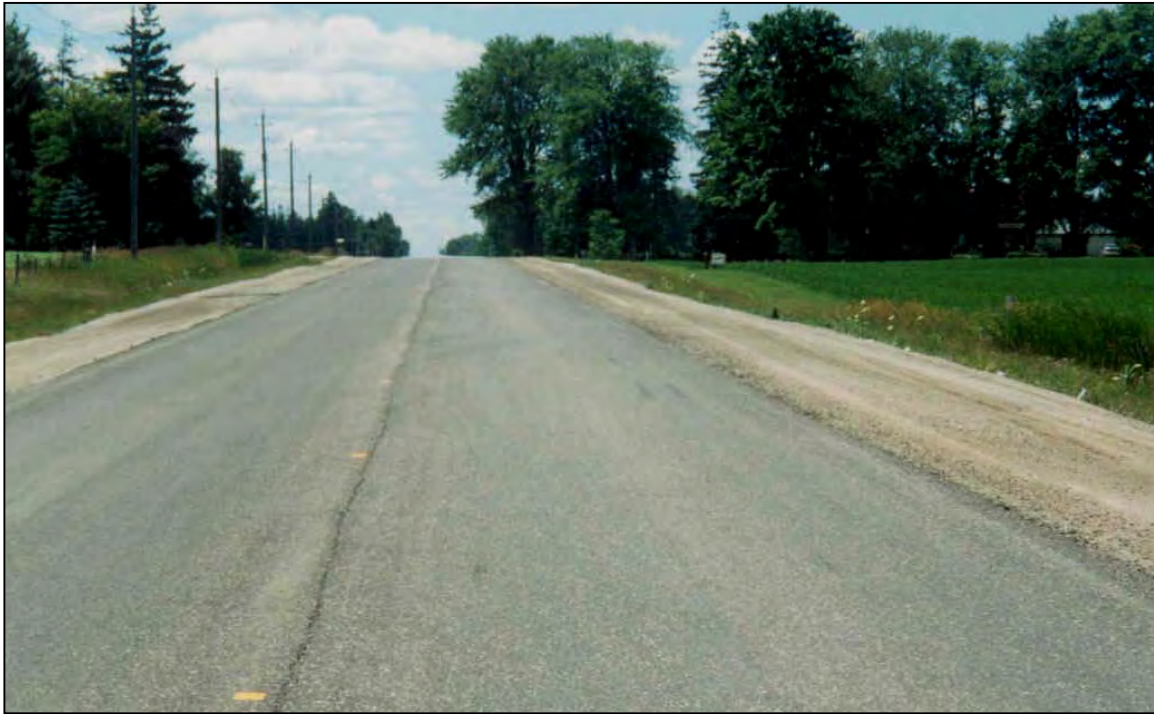
The first layer of cold recycled material cured for about five to seven days (Photograph 9) before the second layer of conventional cold recycled mixture was placed. The total curing time for the two layers of recycled material was approximately four weeks before the HMA surfacing was placed. Phase 3 of the project was completed at the end of August 2001 (Photograph 10).

Photograph 9: Cured stockpiled recycled cold mix

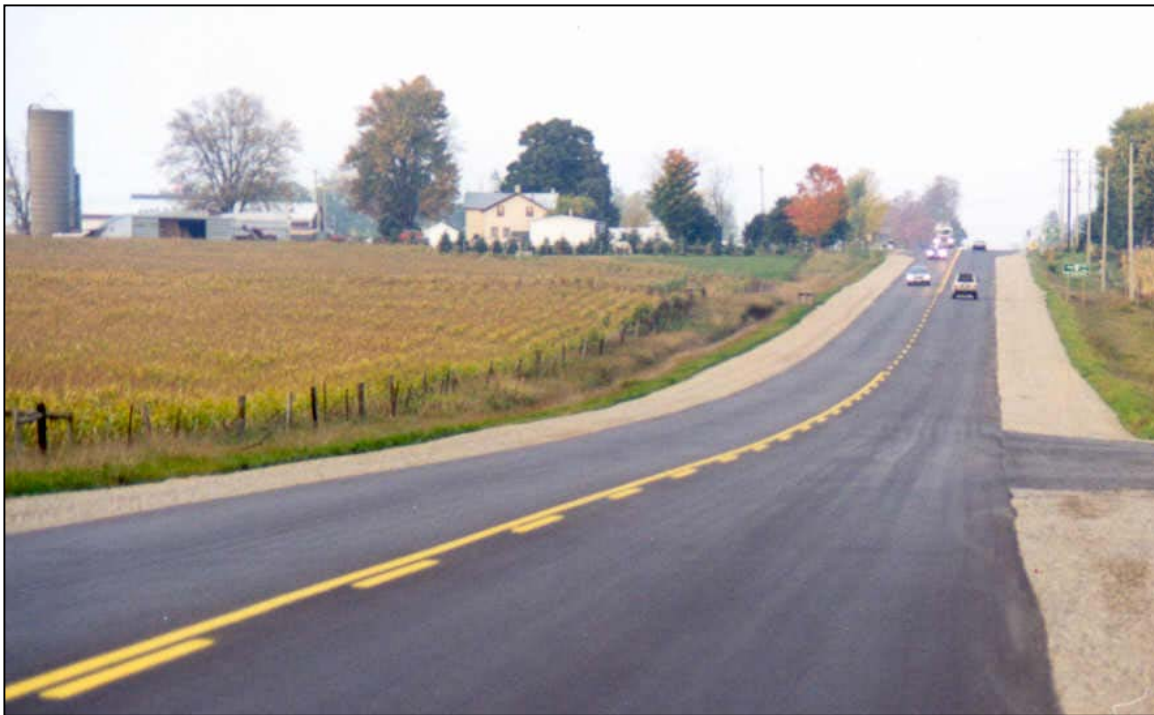
Photograph 10: Completed project
