Optimizing the Effectiveness of High Performance Chip Seals in Ontario

This paper presents the use of high-performance chip seals in Ontario over the last five years. A number of key projects are reviewed, with emphasis on design, construction, and performance, as well as specific discussions on lessons learned, including late season application, repair and re-application of centreline sections damaged by snow ploughs, and repair of flushed areas using water blasting techniques. A summary of the general performance in the field over the five years is assessed, with specific distresses and specific accomplishments.

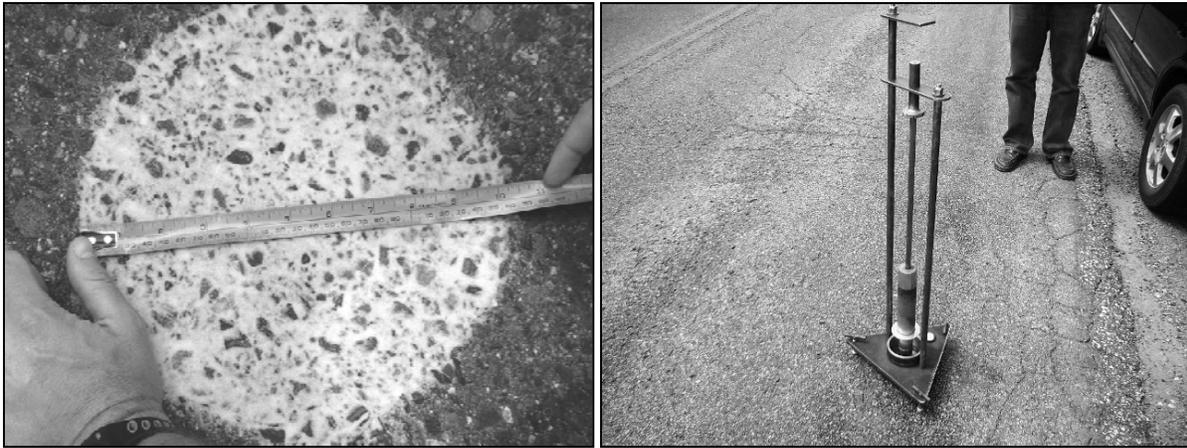
Figure 1. Sand Circle Test and Ball Penetrometer Used in Ontario

Input parameters need to be measured or calculated, and specific tests were developed to quantify some of them. For measuring the surface texture of an existing road, the “sand patch” [2] and the “sand circle” [3] test are the traditional methods. More recently, several ways of measuring surface macro texture electronically are being developed. For determining the hardness of the existing pavement, one of the available methods is the Ball Penetration Test, developed in Australia and New Zealand [4]. Figure 1 shows the application of the Sand Circle test and the use of the Ball Penetrometer.

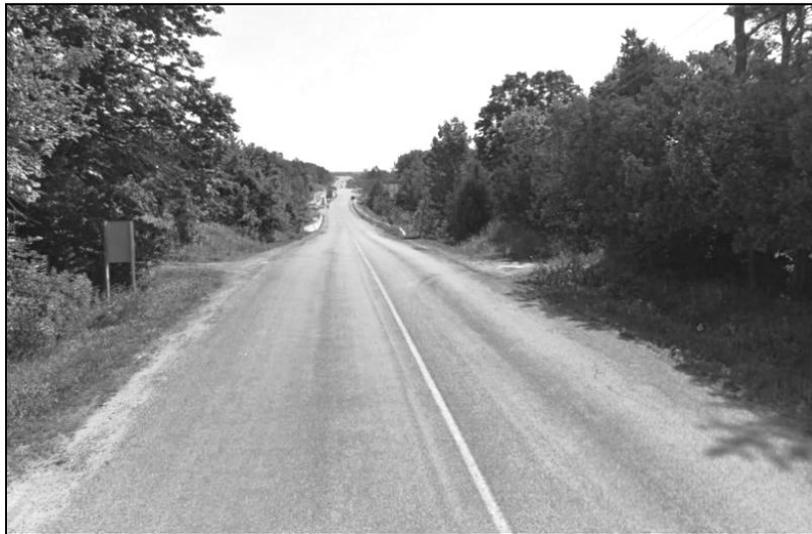
Figure 2. Teston Road Single Chip Seal as it Appears in 2011

The design outcomes provided us with a comfort level to designate the seal coat best suited to each road section. The designs were such that three of the eight roadways required single applications, each having unique spray rates along with condition modifications for uphill lanes on steep inclines, while five roadways required double seal coats of which there were three different total binder rates and one binder rate condition modification for an uphill lane on a steep incline. When we disclosed these findings, the Region was interested in a change proposal to adopt these applications to their roads in place of the initially specified single treatments. As stated previously, five of the eight sections were treated utilizing a double seal coat system of CRS-2P asphalt emulsion and alternate layers of a 6/10 mm stone (OPSS 1006 Class 1) and 2/4 mm chip. At this time all but one of these road sections are still in service today after 6 years, although some are showing signs of snow plough damage on the high areas. The only other distress is the loss of surface texture, which is common with the use of limestone aggregate in this region on surface courses. This typical performance is illustrated in Figure 2.

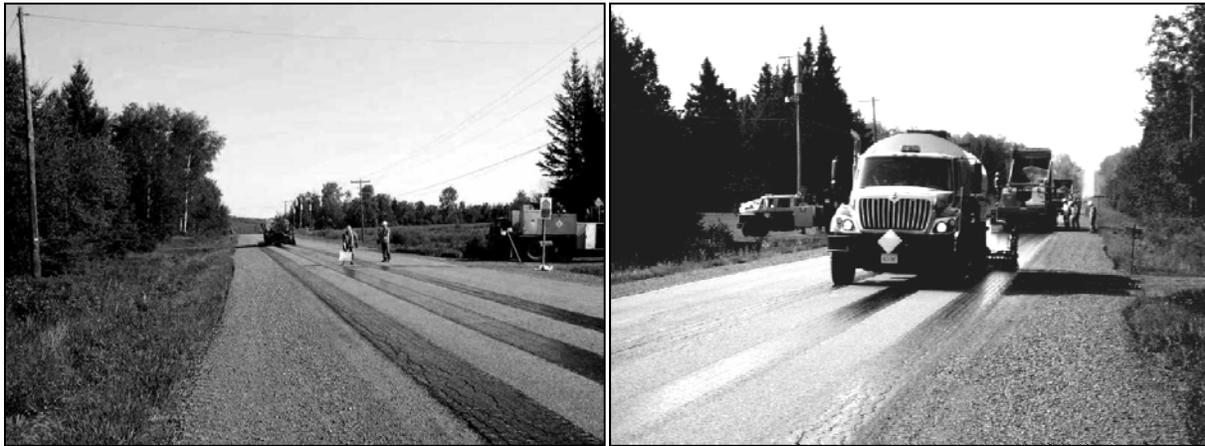
Figure 3. Construction of Highway 590 with the Use of Differential Spray Rate

The project was about 13 km long and its construction was done in August 2007. Three distributors were used, the first one spraying the excess binder at the centreline, centre lane and road edge and leaving about two feet of space in each wheel path. The second distributor was following immediately behind and was applying a uniform layer across the whole lane. The third distributor was used to spray the second lift of emulsion. Subsequently, the construction was done like any HPCS. The resulting total spray rate varied between the wheel paths and outside the wheel paths by as much as 0.5 to 0.6 L/m^2 . This approach allowed the construction of a solid centreline and centre lane that will be resistant to snow ploughing. At the same time, it minimized the risk of flushing in the wheel paths. A picture of the variable application of the emulsion on Highway 590 is shown in Figure 3.

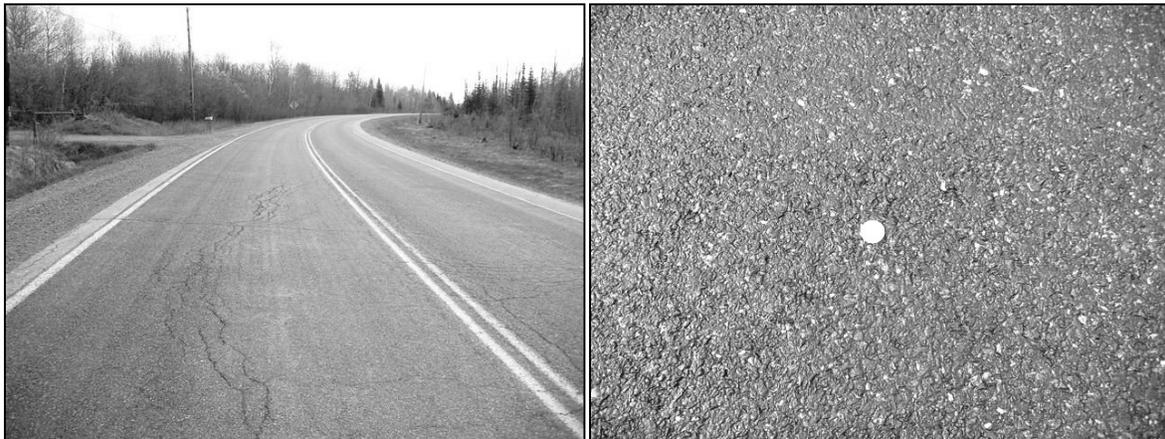
Figure 4. Typical Road Condition and Road Macrotexture for Highway 590 in 2011

This section of road is in excellent condition today. Some of the cracking has reflected through, and this was expected by all parties at the construction time. Otherwise, the road texture is excellent, the plough damage is minimal, and the road condition is very good overall. Figure 4 shows the condition of Highway 590 during the spring of 2011.

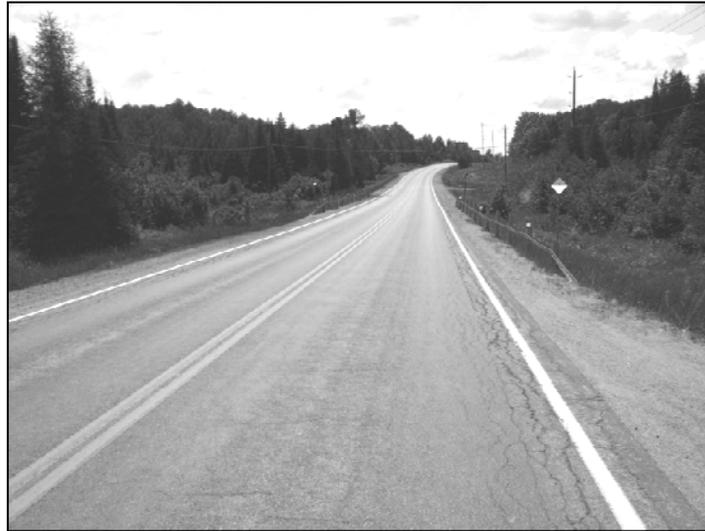
Figure 5. Illustration of Typical Pavement Condition in 2008 Prior to Construction

The pavement was originally constructed with 50 mm of HL-4 HMA in 1992 and was then sealed with a double surface treatment through four separate contracts between 2001 and 2004. Due to the nature of the materials and design method utilized during construction of the double surface treatment at the time, polishing and flushing was evident in many areas in 2008. Figure 5 illustrates the typical condition of the pavement prior to the HPCS application in 2008.

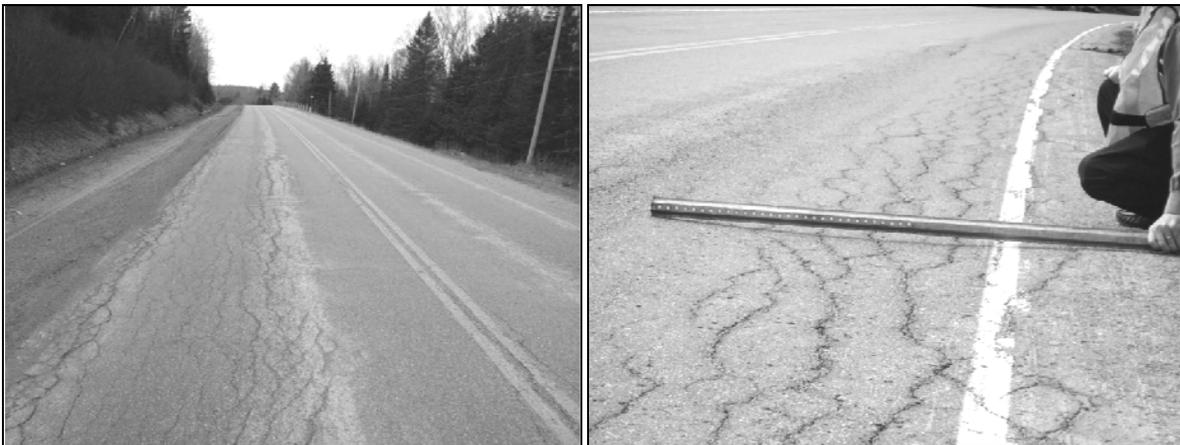
Figure 6. Illustration of Areas Requiring Hot Mix Asphalt Patching

In addition, isolated areas exhibited edge line cracking, deformation, rutting, and inadequate cross slope that were repaired with a scratch overlay of HMA under the contract. Figure 6 illustrates typical areas patched with HMA prior to the application of the HPCS in 2008.

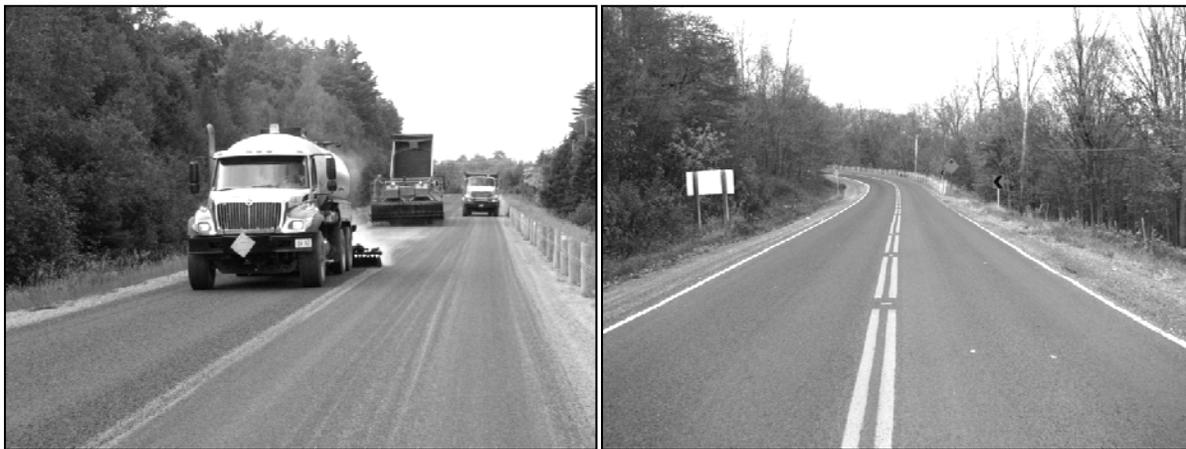
Figure 7. Illustration of Construction and Completed Double Seal Coat on Highway 28 in 2008

The HPCS was placed in September producing an excellent surface with no contractual issues. Upon inspection of the completed seal in early October, the mat was typical of other HPCS constructed under

the same specification since 2006. Figure 7 illustrates the construction and appearance of the completed surface.

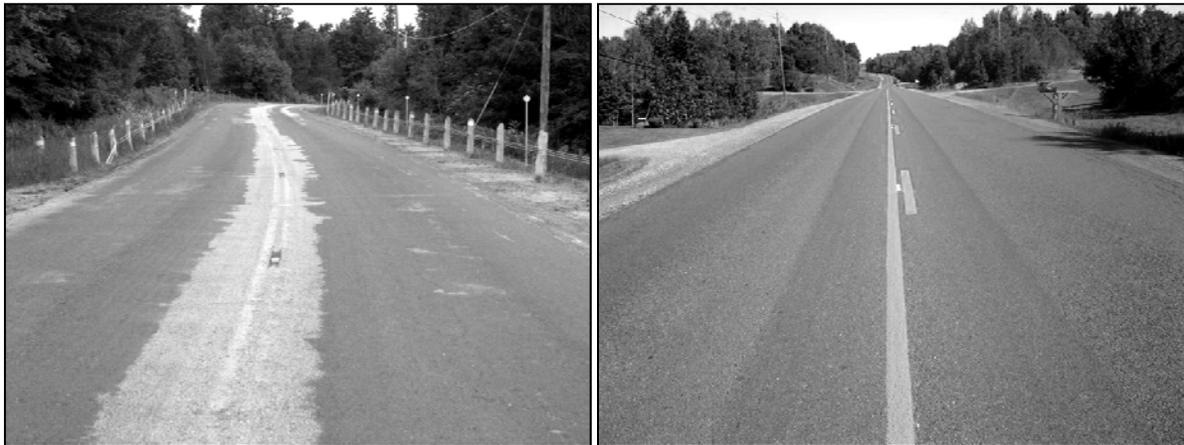
Figure 8. Illustration of Centreline Distress before and After Repair

The damage was mostly concentrated at the centreline of the roadway with some damage observed between the wheel paths. Within the west section of the job near Bancroft, the damage was intermittent, however as the inspection proceeded easterly, the frequency and severity of the damage increased. Through our analysis, we have attributed the aggregate loss from snow ploughs to an incomplete cure of the emulsion utilized for the HPCS. This can be confirmed by two main observations. Firstly, the extent of the damage was worse for work done later in the job than earlier thereby concluding that cold weather delayed the curing process of the emulsion. Secondly, upon inspection of the scarred areas, the emulsion still remained on the existing roadway proving that there was strong adhesion but unfortunately the aggregate was dislodged proving that the emulsion did not possess enough cohesion. We feel that adequate cohesion of the emulsion was not obtained prior to being subjected by snow ploughs due to the low air temperatures in the area from the time the seal was placed until the snow ploughs were first used. In fact, during the month of October but prior to the first snow plough, the average air temperature was approximately 7.5°C. Through experience with chip seals utilizing cationic rapid setting emulsion, it is hypothesized that approximately 30 days of hot weather is required to ensure that the emulsion is fully cured and can successfully withstand the abrasive forces of snow plough blades.

Due to the nature and extent of the damage, repairs to the HPCS were required to remediate the roadway to a safe driving condition. During the summer of 2009 the areas to be repaired and the repair method were established by both the owner and contractor. Since the predominant distress was at centreline, we proposed to apply a one metre treatment of seal coat with the original top aggregate only in these areas.

This would cover most of the areas where aggregate was dislodged from the snow ploughs. The aggregate and emulsion aggregate application rates required modification from the original design, however through past experience in performing similar repairs in 2008, significant confidence was felt with our approach. Figure 8 illustrates typical areas of distress with the corresponding repair seal.

It can be readily observed that the one metre repair treatment blended in very well with the lane portion of the seal that was not affected by the snow ploughs.

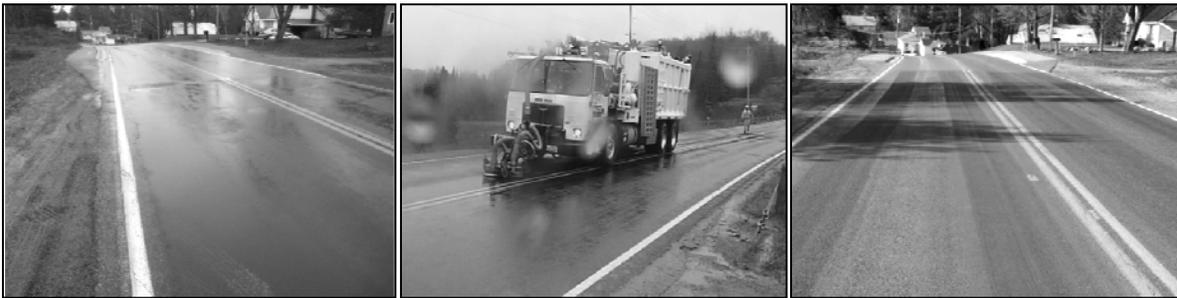
Figure 9. Illustration of Before, During, and After Water Blasting Treatment

At the end of October, the water blasting occurred on Highway 28. It was quickly observed that the equipment was able to remove the excess asphalt cement from the surface and leave the original seal unaffected to withstand the traffic and snow ploughs. Figure 9 illustrates the before, during, after photographs of the water blasting.

To quantify the effect of water blasting to the seal coat surface, the Sand Circle Test was used to measure the macrotexture before and after the asphalt cement was removed. Prior to the water blasting in flushed areas, the macrotexture was found to be approximately 0.5 mm and in normal areas, where no flushing existed, the macrotexture was found to be 1.4 mm. After the water blasting occurred, the macrotexture of the surface was 0.9 mm. Therefore, it was proven immediately on site that the water blasting was effective.

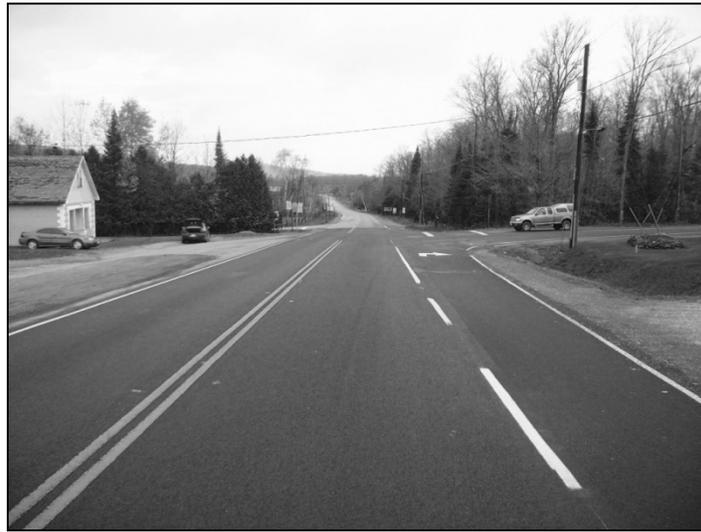
Figure 10. Illustration of the Harwood Lake Intersection after the HPCS Application

During the design stage of this section, it was determined through hardness and macrotexture measurements of the existing pavement that the emulsion rates needed to be reduced significantly to ensure that flushing did not reoccur. The total binder rate for the remainder of the contract section was 2.1 L/m², but due to the flushing tendency of the intersection the total binder rate was reduced to 1.9 L/m².

The rate reduction proved to be adequate as the performance of the seal in the following season was excellent. Subsequent visits to the site have revealed that the surface is somewhat smoother than normal, however it is still providing adequate skid resistance and sealing of the pavement, as shown in Figure 10.

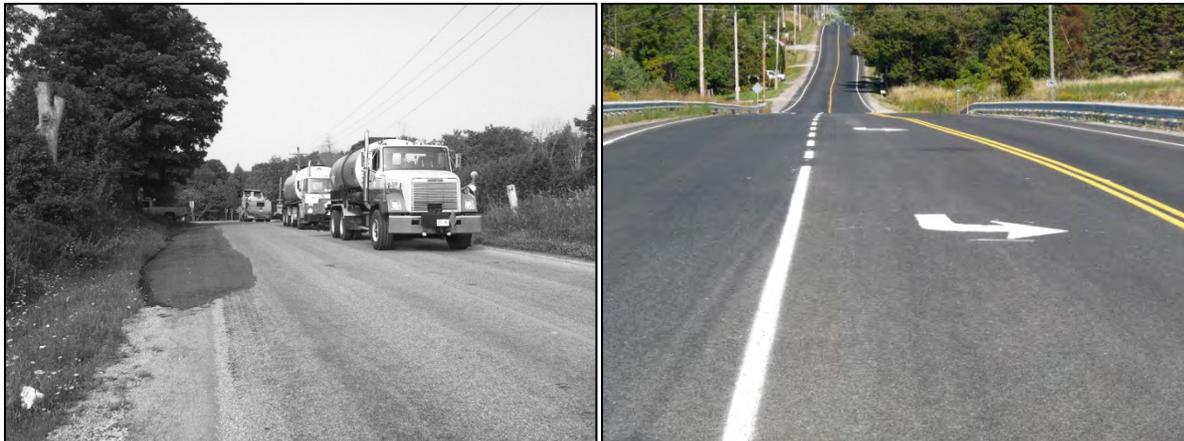
Figure 11. York Region Weston Road, Before and After Construction, 2009

After a review of the 2007 chip seals, The Region of York once again let a tender (09-174) for HPCS over asphalt surfaces on two regional roads. The first was Mt. Albert Road running east-west from the York Durham boundary through the town of Mt. Albert, and connecting to Highway 48. This section had an AADT of 8148 with 10 percent heavy commercial vehicles. The second road was Weston Road running southerly from Highway 9 to Aurora Road with an AADT of 1508 including 2 percent heavy commercial vehicles. Fog coating to reduce the initial macrotexture was included on these projects in order to mitigate noise complaints from the public. A diluted CSS-1H asphalt emulsion was applied to the chip seals at a rate of 0.3 L/m² and a light sand blotter was applied to allow for immediate traffic flow. Weston Road had an adjusted spray rate differential of 0.25 L/m² and it is performing with no damage from winter maintenance activities (see Figure 11). Mt. Albert Road on the other hand had a spray rate differential of 0.55 L/m². This section was affected by the winter maintenance activities, thereby strengthening our theory previously stated concerning large spray rate differentials. As this work was completed in July the average daily temperatures of the succeeding 30 days was over 20 degrees.

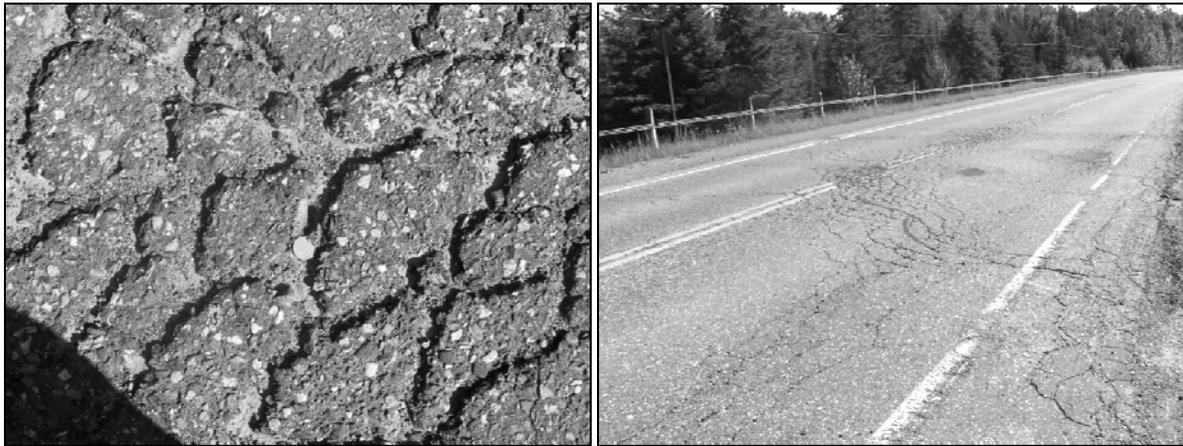
Figure 12. Wide-Spread Block Cracking on Highway 11B

In 2009, the MTO's Northeastern region let their first HPCS project utilizing the contractor design method. The road way designated for this application was Highway 11B running from Highway 11, a major north-south route linking Northern Ontario communities to the South. Highway 11B is a business section link into the Town of Cobalt and runs north to New Liskeard. The section to be treated was designated by the MTO as a "holding strategy" as its condition was well below that of a preservation candidate. The road consisted of many areas of block cracking throughout and exhibited bumps and ruts (Figure 12). The more severe ruts were padded with HMA prior to chip sealing.

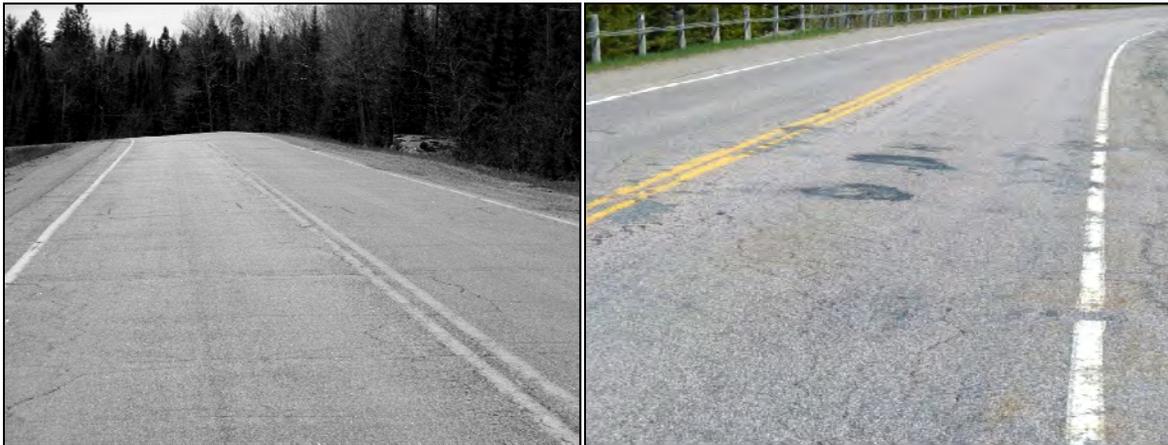
Figure 13. Highway 11B Typical Condition and Localized Plough Damage in 2011

The differential between adjusted and the unadjusted spray rate was only 0.07 L/m² and to this day we have witnessed only damage by winter maintenance equipment on the surface where the pavement was extremely uneven as localized high spots. The average temperature of the succeeding 30 days was 19 degrees Celsius. Figure 13 shows the current condition of Highway 11B.
