Mixture Design and Field Experience: Coloured Hot Mix Asphalt on Bus Rapid Transit (BRT) Lanes in Ontario

Sina Varamini, Ph.D., P.Eng.
Research and Development Manager
McAsphalt Industries Limited
(Adjunct Assistant Professor at University of Waterloo)
Toronto, Ontario

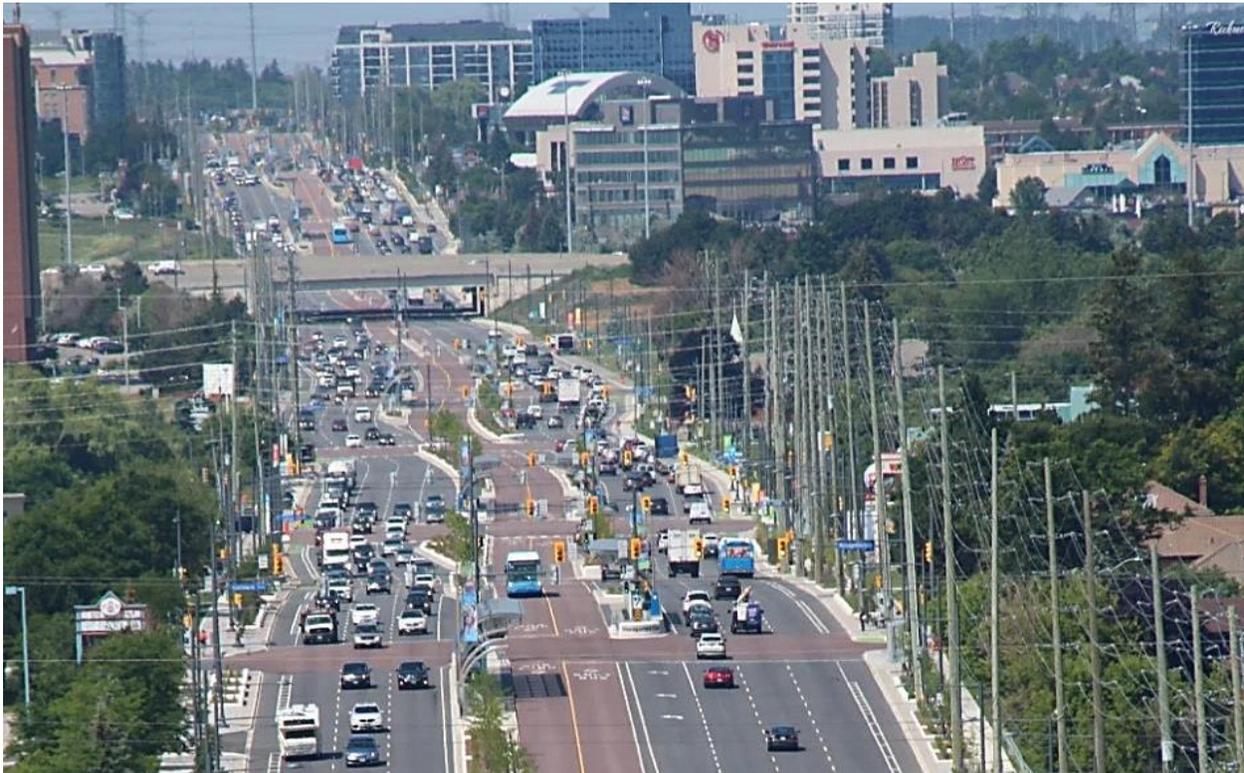
Figure 1. Highway 7 Bus Rapid Transit (BRT) Lane, York Region, Ontario. Picture Taken in 2016.

York Region, located in Greater Toronto and Hamilton Area (GTHA), is the sixth largest municipality in Canada with a population of 1.14 million in 2014, representing a 16 percent share of 2014's GTHA population. The Region's population is expected to grow to 1.8 million by 2041. To meet the rapidly increasing need for public transit, York Region has installed dedicated Bus Rapid Transit (BRT) lanes along the three most heavily travelled roads in the Region; Yonge Street, Highway 7, and Davis Drive. In order to increase visibility of the BRT lanes, York Region used a combination of coloured aggregate and red pigment as surface course (Figure 1).

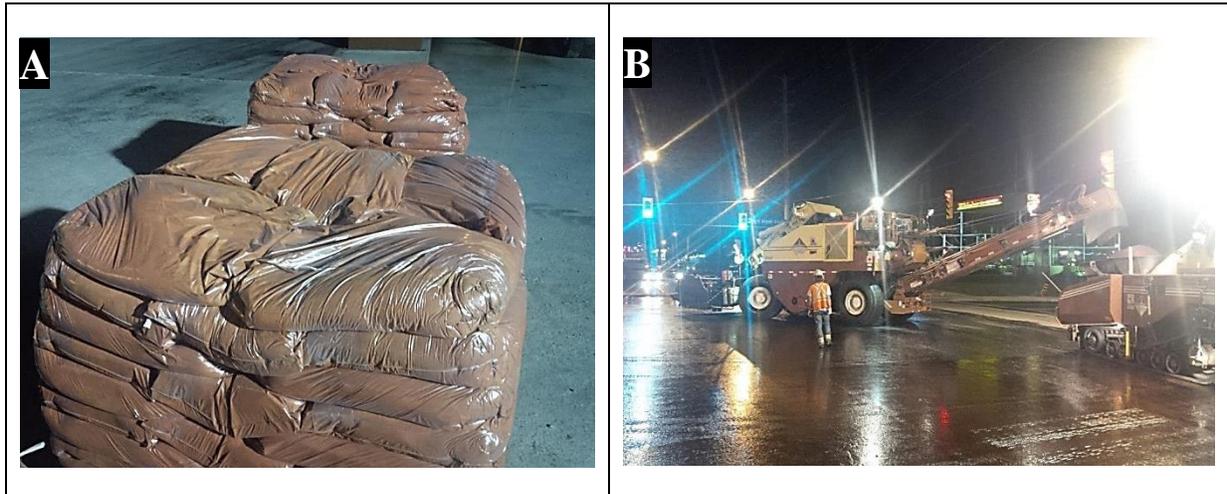
Figure 5. (A) Red Pigment in Packaging Designed to Melt, and (B) Conventional Paving Equipment Used in Paving Highway 7 Bus Rapid Transit (BRT) Lanes in Ontario

The mix was delivered to the roadway by conventional haulage equipment and placed with conventional paving equipment shown in Figure 5(B). Again, special consideration was taken to ensure the paver was properly cleaned before and after placing the red asphalt to prevent colour contamination. Trucks required thorough cleaning to remove any remaining black hot mix and other contaminants. Trucks were inspected prior to loading nightly to ensure the boxes were clean. Release agent was strictly monitored for proper application as any over application could also cause detrimental effects to the hot mix.
